**ATTACHMENT 8**  
**Declaration of Joseph L. Shelnut**

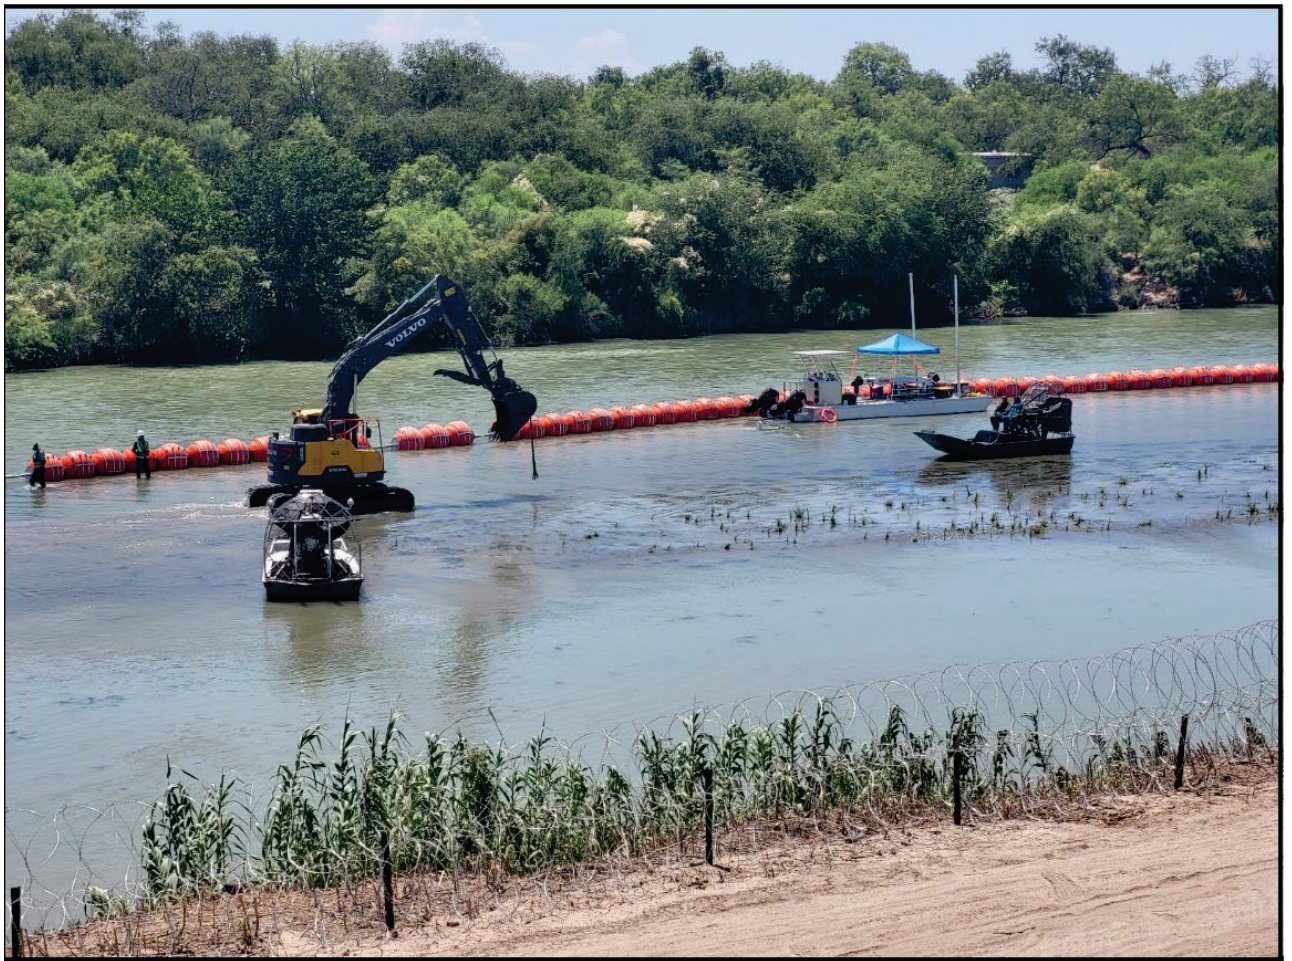
11. This is a photograph of the work on the floating barrier we witnessed during our site visit. I took the photograph:
